INVENTORY LISTED

Check Out

Address	123 Sample Street, Sample City, Sampleshire, AB1 2CD
Date	December 17th 2025
Clerk	A. Clerk
Client	Example Lettings Ltd

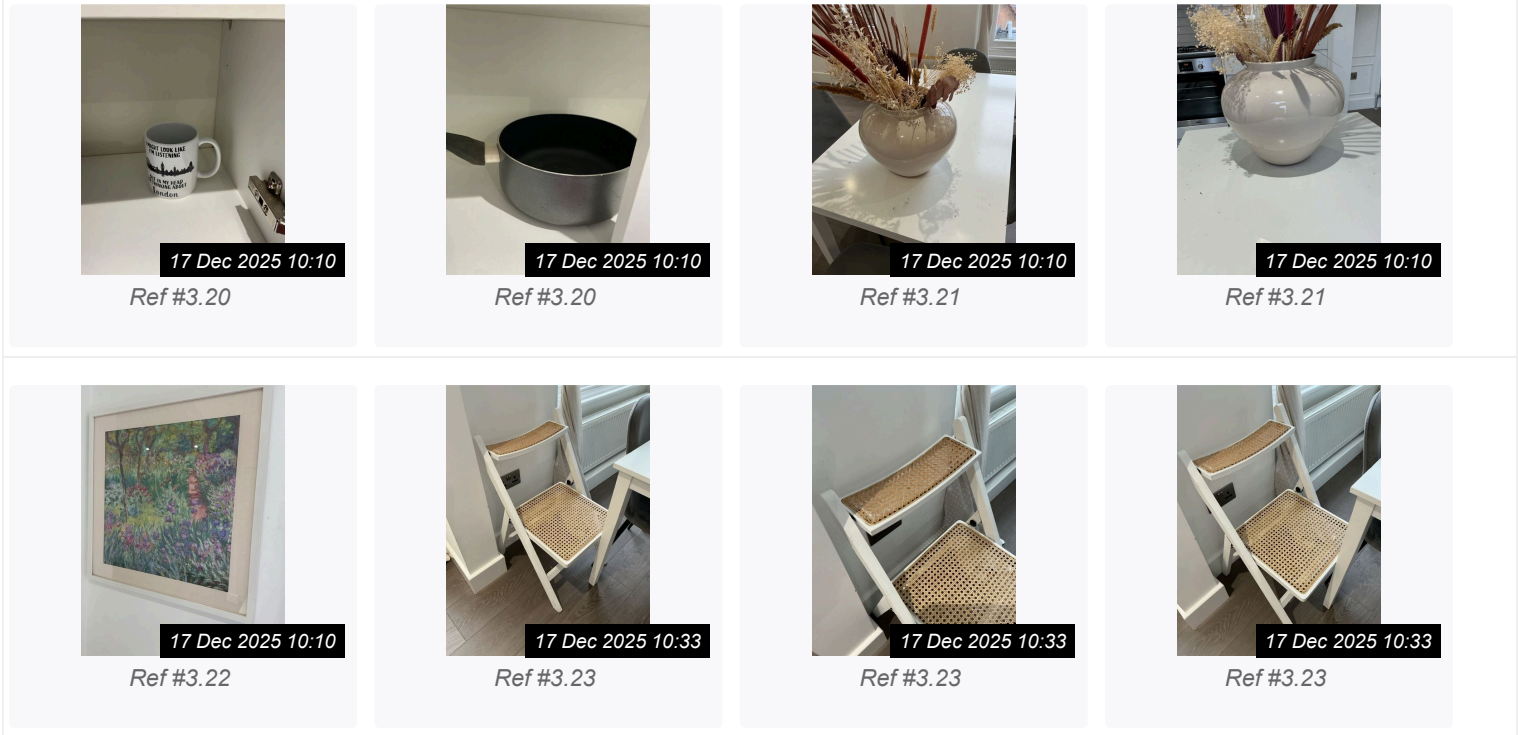
Ref #3.20

<p>3.20 📷</p>	<p>Tableware/ Cookware</p>	<p>A small quantity of tableware comprising: 2 grey bowls 2 grey dinner plates 3 side plates Black and white coffee mug Double handled pan Ditte without lid Ditte-saucepan Saucepan without lid</p>	<p>. Well in use Well in use Well in use</p>	<p>1 x dinner plate missing Needs Replacing - Tenant</p>	
<p>3.21 📷</p>	<p>Vase</p>	<p>Large beige pottery vase containing imitation grasses</p>		<p>Appears in good condition</p>	
<p>3.22 📷</p>	<p>Artwork</p>	<p>A small floral print framed and glazed wall mounted</p>		<p>Dusty to top of frame Needs Cleaning - Tenant</p>	
<p>3.23 📷</p>	<p>Additional Items</p>	<p>White wooden frame with natural wood coloured rattan base and back support folding chair</p>	<p><i>Item added after Check In</i></p>	<p>Back support is loose Needs Maintenance - Investigate</p>	<p>f*@plazaestates.co.uk: This is part of the older chairs set that got replaced with the grey ones. 08 Jan 2026 16:46</p>

3.20 KITCHEN » Tableware/ Cookware	Needs Replacing	Tenant	1 x dinner plate missing
3.22 KITCHEN » Artwork	Needs Cleaning	Tenant	Dusty to top of frame
3.23 KITCHEN » Additional Items	Needs Maintenance	Investigate	Back support is loose
