INVENTORY LISTED

Check Out

Address	123 Sample Street, Sample City, Sampleshire, AB1 2CD
Date	December 17th 2025
Clerk	A. Clerk
Client	Example Lettings Ltd

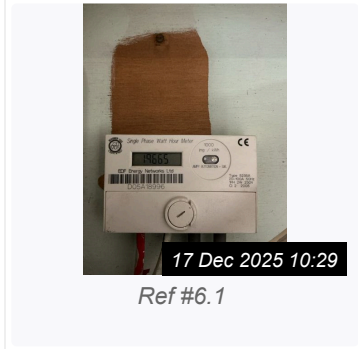
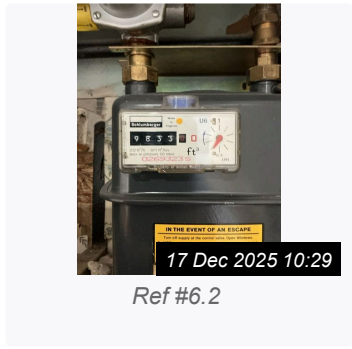
Gas:	Ref: 269323 S	9502	9833	Cupboard behind front door

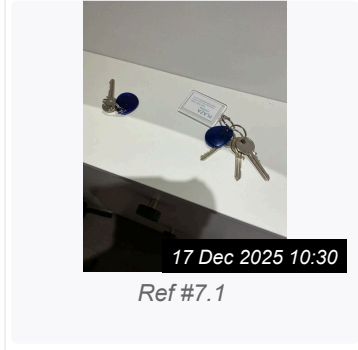
Keys:	2 sets given to tenant; 2 x key entry fobs 4 x Yale keys <i>Keys left in property by tenant, returned to agent;</i>
